NASA TN D-1458

PRELIMINARY INVESTIGATION OF EFFECT OF HYDROGEN ON
STRESS-RUPTURE AND FATIGUE PROPERTIES OF AN
IRON-, A NICKEL-, AND A COBALT-BASE ALLOY

By Stanley J. Klima, Alfred J. Nachtigall,
and Charles A. Hoffman

Lewis Research Center
Cleveland, Ohio

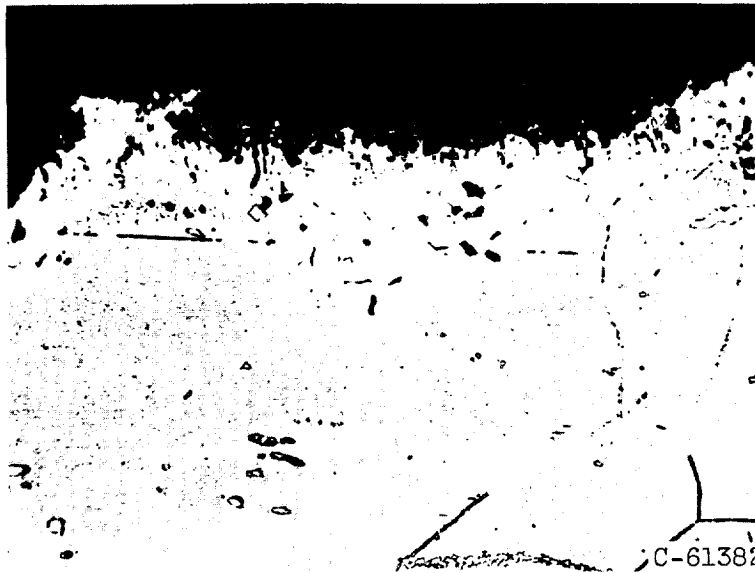
(b) Inconel 700; fatigue test; life, 83.4×10^6 cycles (705.5 hr).

Figure 9. - Continued. Typical specimens showing both internal and external surfaces in region of failure. Internal surface exposed to dried air; external surface exposed to relatively humid air. X500.

Figure 9 shows typical microstructures along both the internal and the external surfaces of specimens of each alloy after air tests in the areas near the specific points of failure. Figure 10 presents similar

photomicrographs of additional specimens of each alloy, which show regions away from the failure area. It is apparent from these figures that, in general, a considerably thicker scale was formed on the external surface exposed to relatively humid air rather than on the internal specimen surface exposed to dried air. This scale extended through both the cracked and uncracked areas. Microscopic examination indicated that considerable oxidation occurred in the cracks that formed near the point of failure of air-tested specimens in all the materials investigated. Oxidation occurred in the cracks that extended from the internal surface as well as those that extended from the external surface. This was most apparent in stress-rupture tested specimens and is best illustrated in figure 9(c). No oxidation occurred in the cracks that extended from the internal surfaces of specimens exposed to hydrogen.

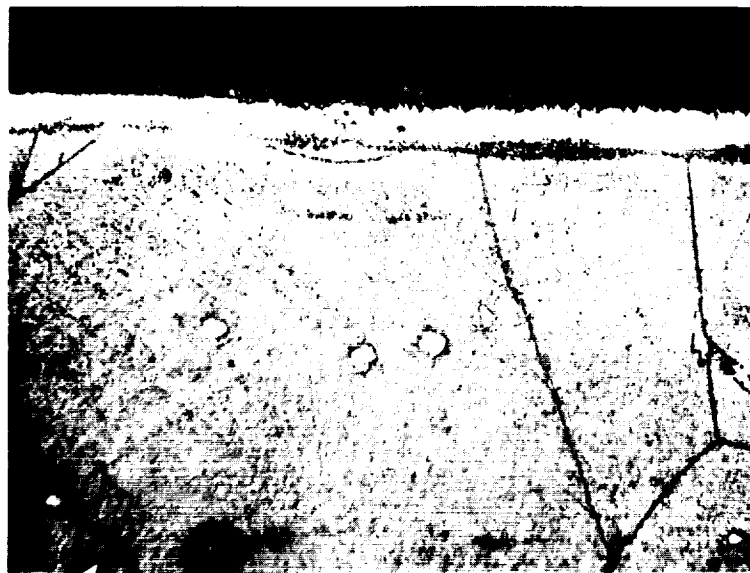
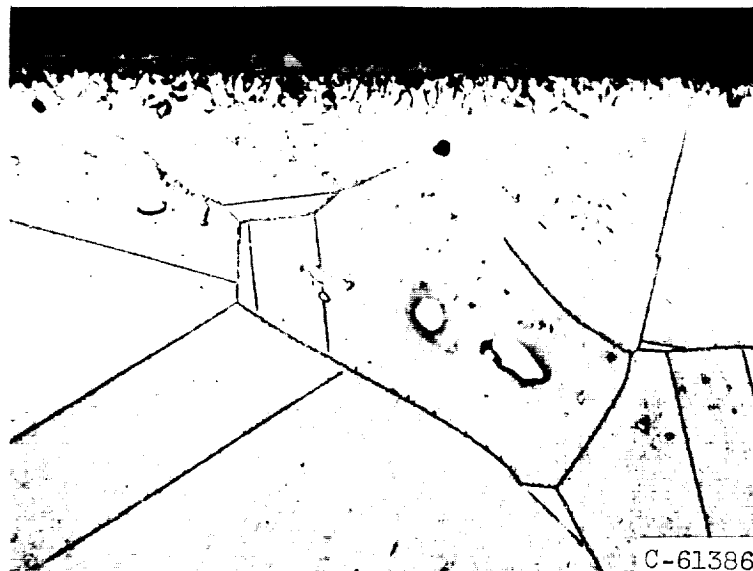
(b) Inconel 700; fatigue test; life, 47.4×10^6 cycles (401.6 hr).

Figure 10. - Continued. Typical specimens showing both internal and external surfaces in area some distance from region of failure. Internal surface exposed to dried air; external surface exposed to relatively humid air. X500.
